CASE STUDY

The Gunnery Historic Restoration

The Gunnery is a threestorey State Heritage building on Sydney Harbour in Woolloomooloo built in 1900. Fireshield Steel 1001 was used to fire rate the existing timber floor and roof structure.

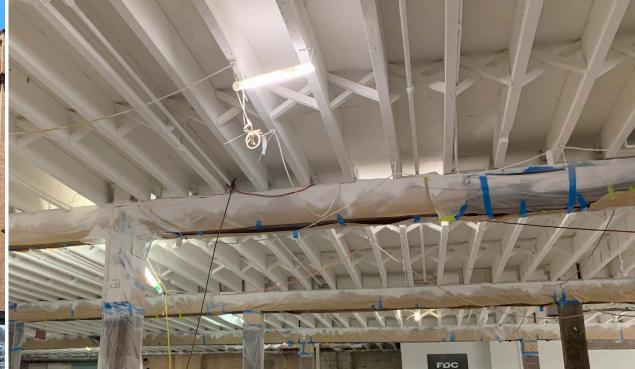
Fireshield Steel 1001 can be used to protect and reduce the char rate of existing historical structural timber members.

Fireshield completed a specific design solution that allowed FDC to apply the pigmented Steel 1001 to the existing timber structure providing the fire rating required. The protected timber could be left exposed, top coated any colour or enclosed behind the suspended ceiling system.
